Report on trends in shuttle tanker incidents 1998 – 2001

Prepared by **Global Maritime Consultancy Limited**
for the Health and Safety Executive 2003

RESEARCH REPORT 111

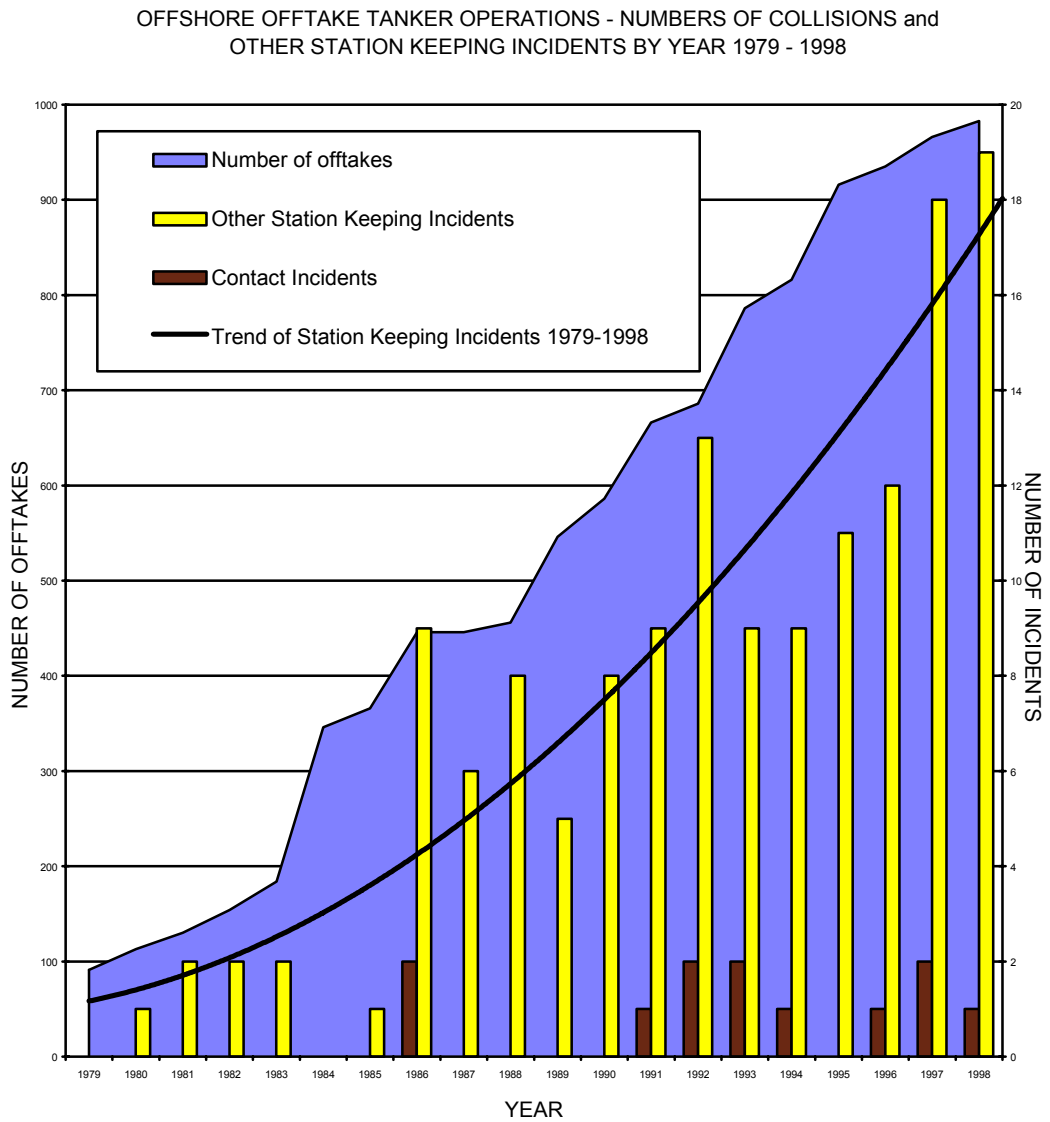
Fig. 3

The figure reproduced below shows the trend at the time of publishing and before all the 1998 data was available. Generally the increase in incidents followed the increase in number of offtakes.

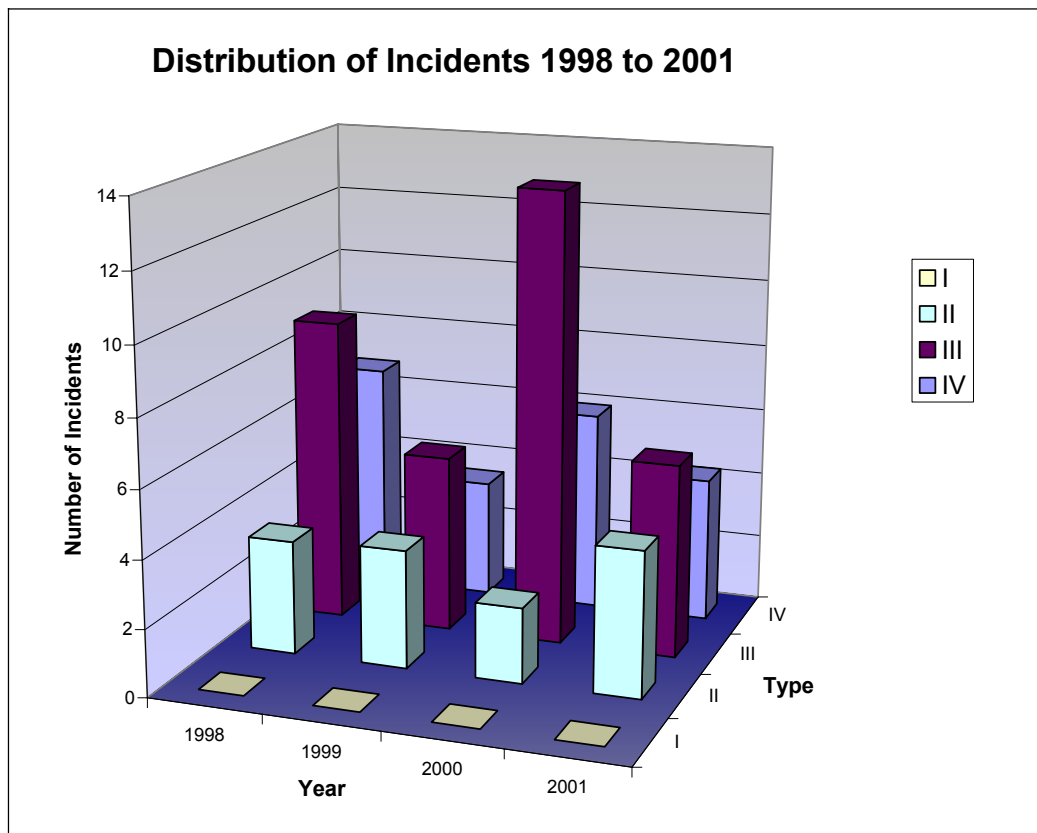
Fig. 11

Using the levels described in section three and normalising them per 8,760 hours (1 year) we can see the relative progress:

No clear conclusion can be made except perhaps that the variation is small especially for the level 2 incidents. The measurement of success should be in level 1 and level 2. An increase in level 3 and level 4 would be positive if it showed more reporting and greater awareness.
