Travis Perkins - building safer deliveries

Reducing falls from vehicles case study 12

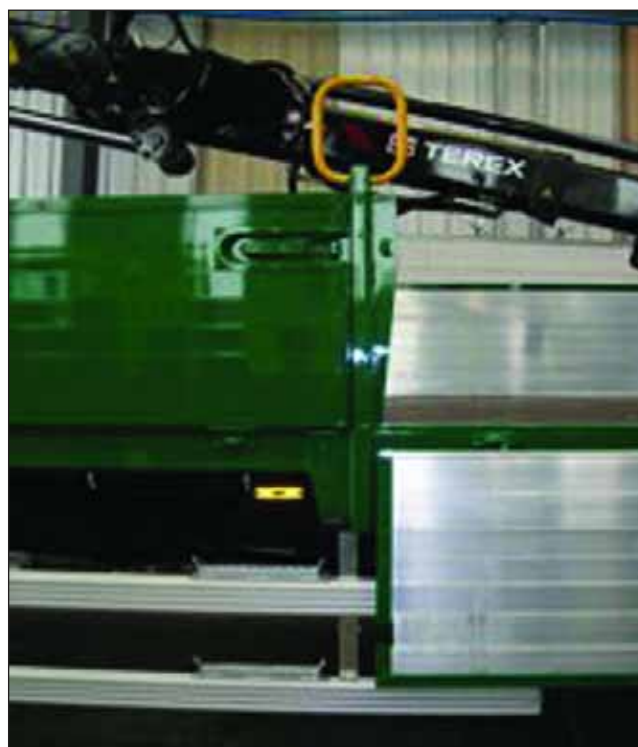
Figure 1 Side access steps and handhold.

Travis Perkins have now provided access at the centre of the bed of the vehicle, fitting handholds on the central posts, and improving the grip by introducing a new surface to the side rails of the body where it is well known their employees climb up.

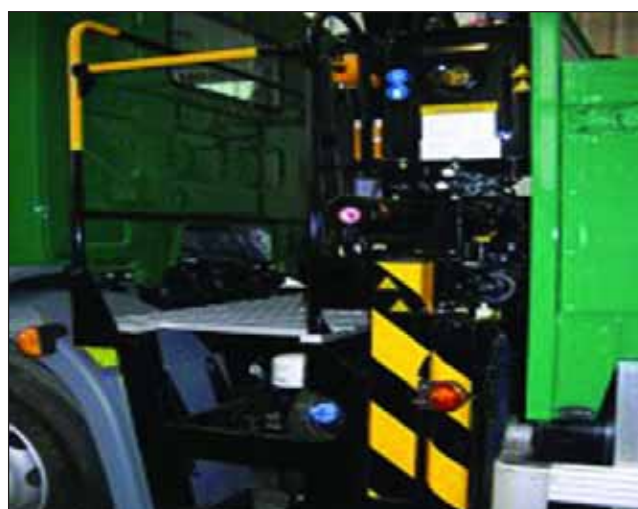
Figure 2 Crane access and working platform

From 1998, safe working platforms have been fitted near the headboard of the vehicle (with front mounted cranes) so the operator can safely use the controls, and have a relatively clear view of the load. This has been improved further with a better slip-resistant surface for the access steps, a suitably placed handhold to assist the operator when climbing up or down, and a working platform with full edge protection from which to work safely, with no risk of falling from the vehicle. A cut-out is also being provided in the headboard to allow access onto the vehicle bed.

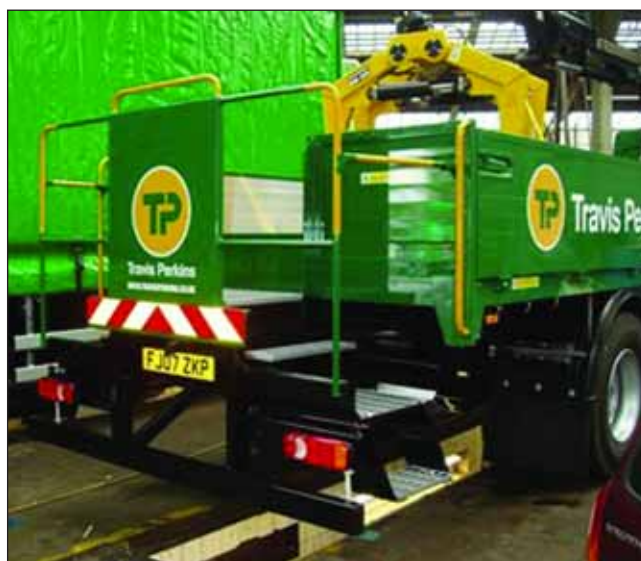
Figure 3 Bespoke rear access and working platform

Finally, the rear of the vehicle will be provided with dedicated access steps and working platform. The tail board has also been cut out to allow safe access onto the bed of the vehicle when necessary.
