Brief intro on field Team in Scotland – the team is responsible for the day-to-day inspection and investigation work over the rail network in Scotland including offering guidance and support to Network Rail and other duty holders in the rail industry.

Level Crossings

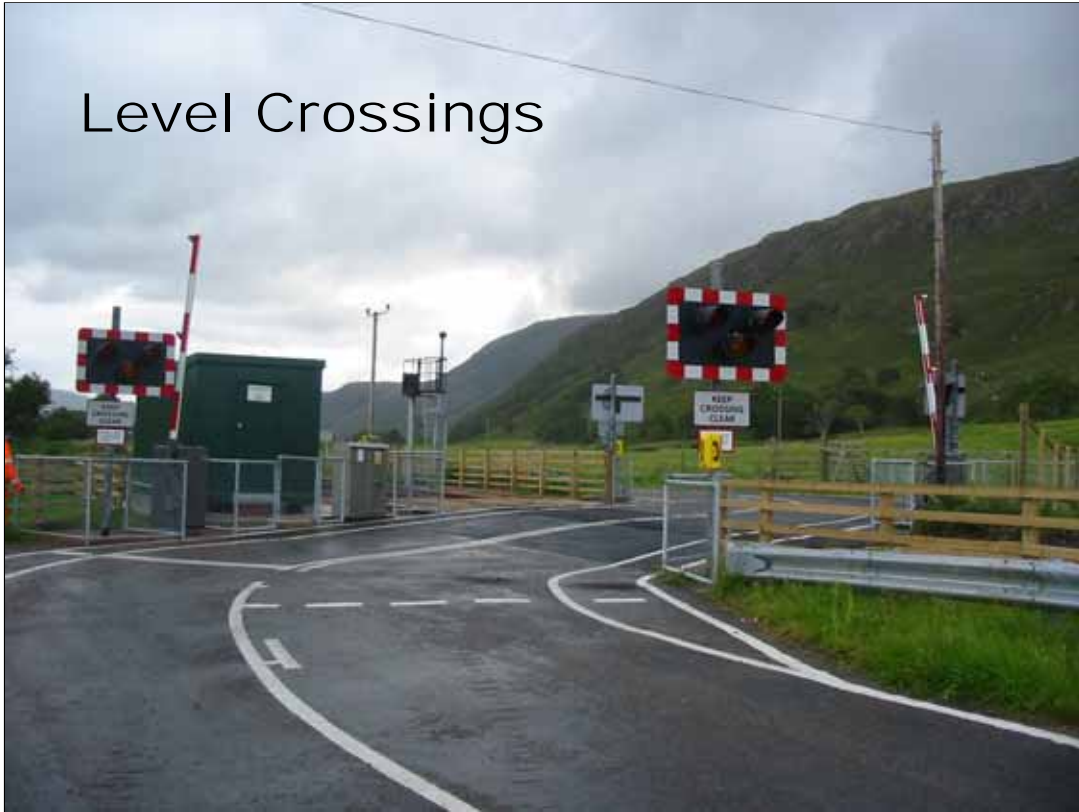
Level Crossings currently present the largest source of train accident risk. – They present conditions for conflict between road and rail traffic and any collision has the potential to cause a derailment resulting in a major train accident.

A photograph of a railway level crossing. In the foreground, there is a paved road with a white line marking. To the right, a yellow and black striped barrier is partially visible. In the background, there are two red and white striped barriers, a signal post with a red and white checkered light, and a sign that reads 'STOP CROSSING'. The background shows a green hillside under a clear sky.

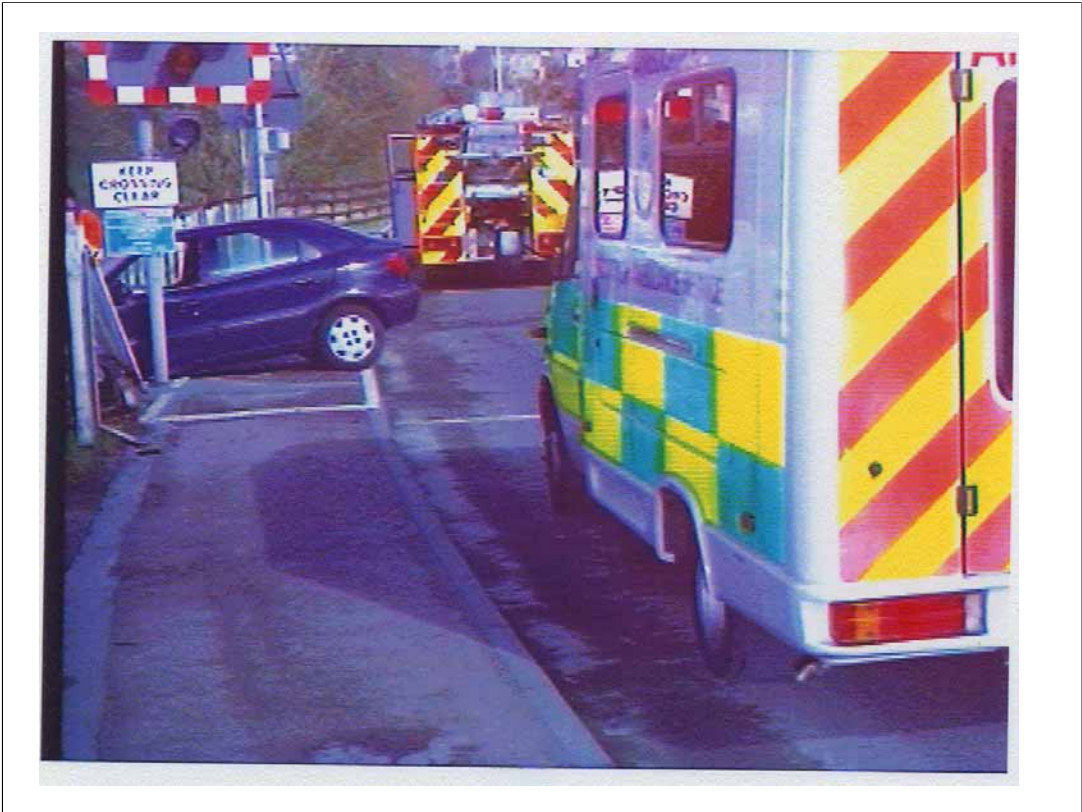
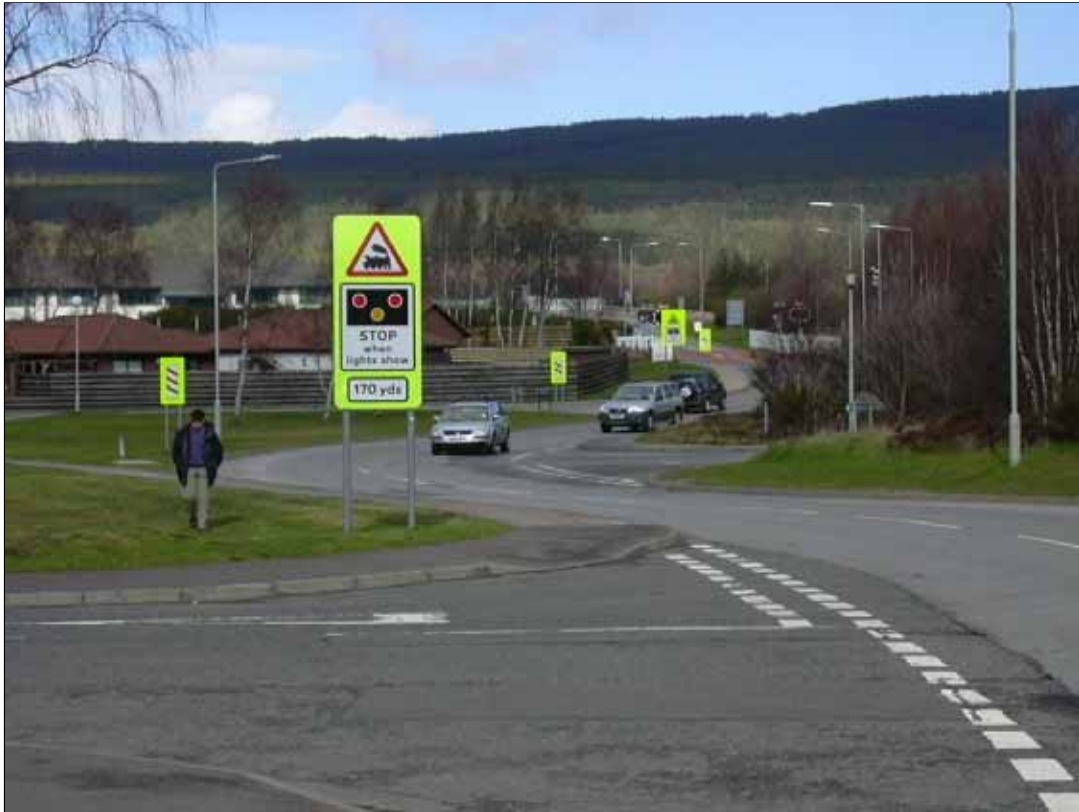
Work is continuing on raising the awareness of users through better signage and roadmarkings and the involvement of human factors engineering.

The example of enhanced signage and count-down markers at a level crossing in Aviemore is a good example of what can be done, but each crossing has different problems and what is good for one may not necessarily be the best solution for another.

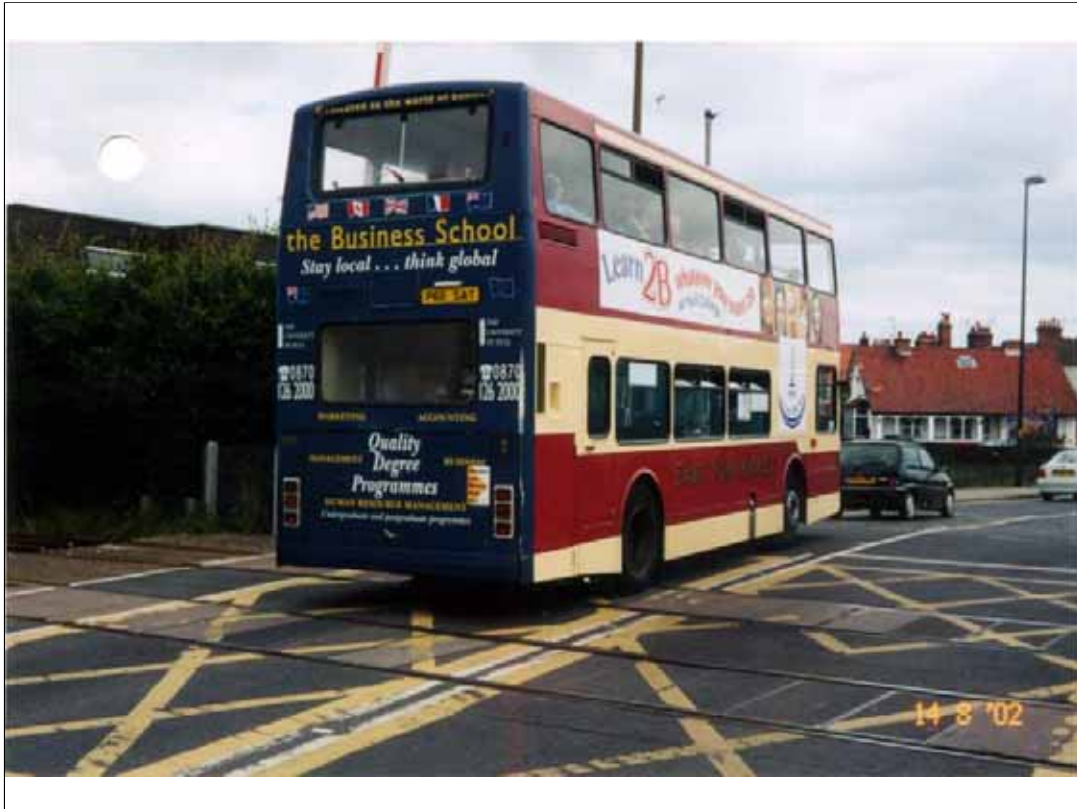
Other risks include traffic backing up over the crossing and drivers ignoring yellow box markings – these risks are assessed by Network Rail on a regular basis and any remedial action taken as necessary.

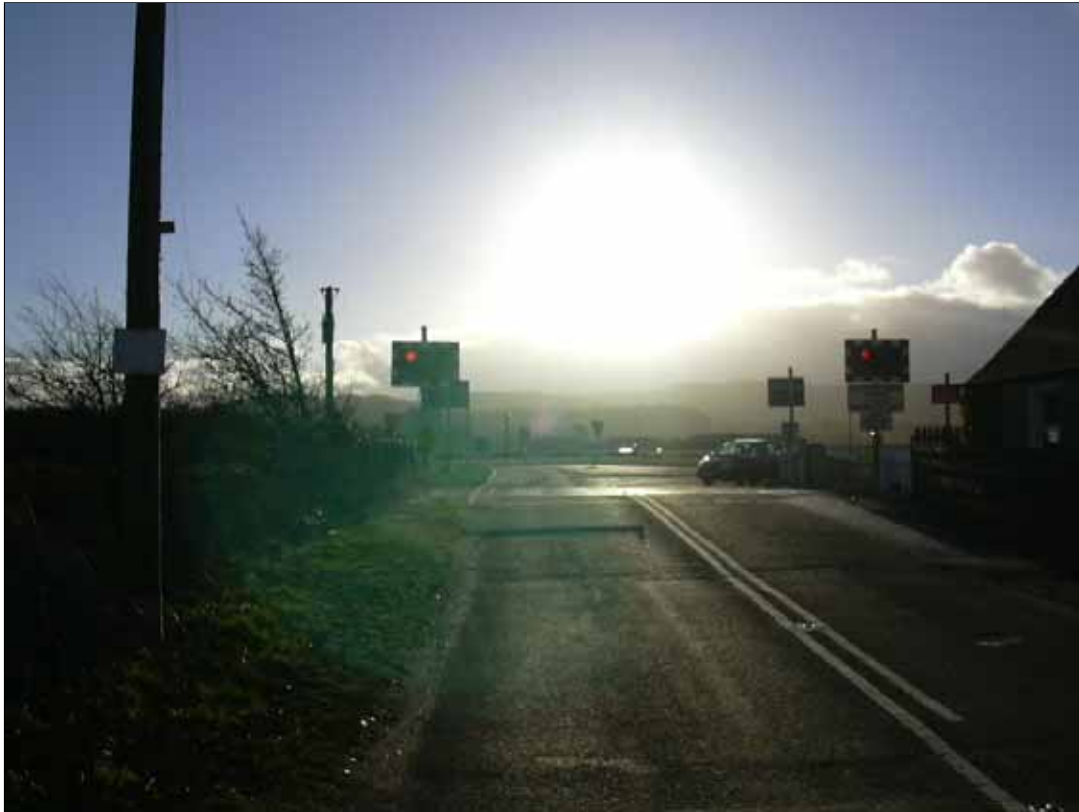
An accident early this year when an elderly motorist drove onto a level crossing, on the wrong side of the road and into the side of a train, highlighted the hazardous effects that low sun can have on driving.

Investigation into the incident showed that the crossing was functioning correctly and complied with current standards.

Many crossing locations in Scotland can be affected by low sun, however there are limited measures that can be taken to improve the visibility of crossing signs in such conditions. Backboards to the warning lamps and long hoods can help a little, but ultimately it is up to the road user to ensure that they take extra care in such conditions.

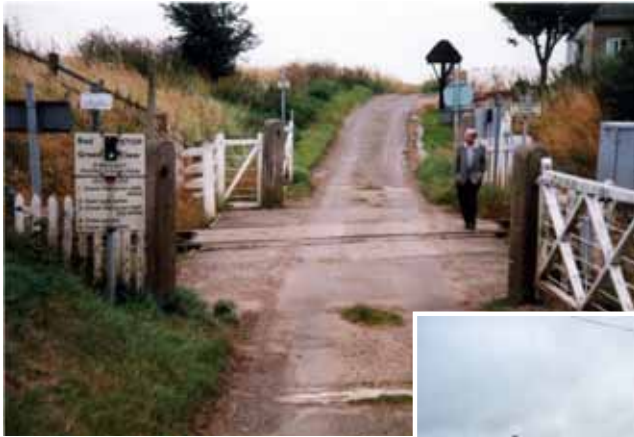
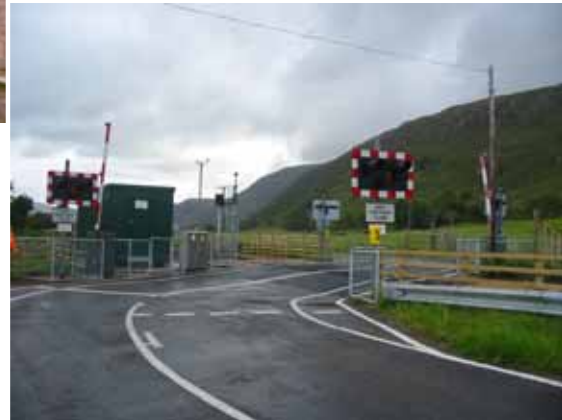
£500,000

Safety at crossings can sometimes be improved by upgrading the crossing – for example from an open crossing to one fitted with barriers.

But the upgrade of crossings can be a very expensive undertaking because the equipment has to be linked into the train signalling systems.

It costs somewhere in the order of half a million £ to upgrade a user worked crossing to one like this.

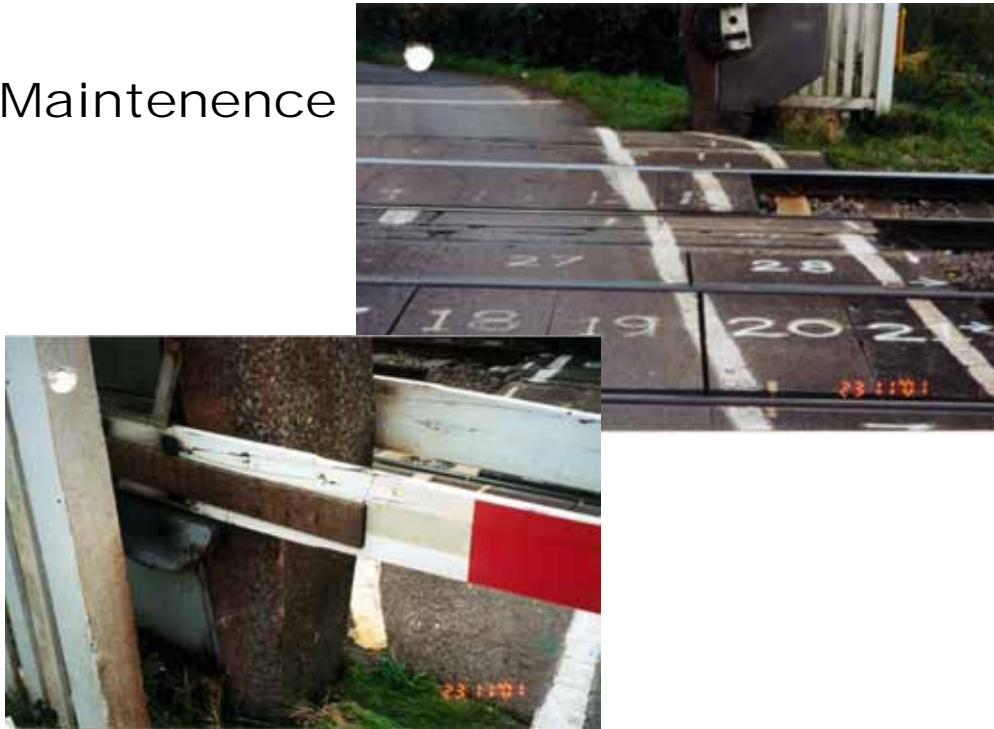
Maintenance

It may be a little unfair showing these slides as the vast majority of LC equipment is maintained well. (and the slides are not from Scotland)

Level crossing surfaces are one area which requires constant inspection and maintenance as they can cause hazards especially to pedestrians and cyclists, and if they become loose can cause a derailment hazard to trains.

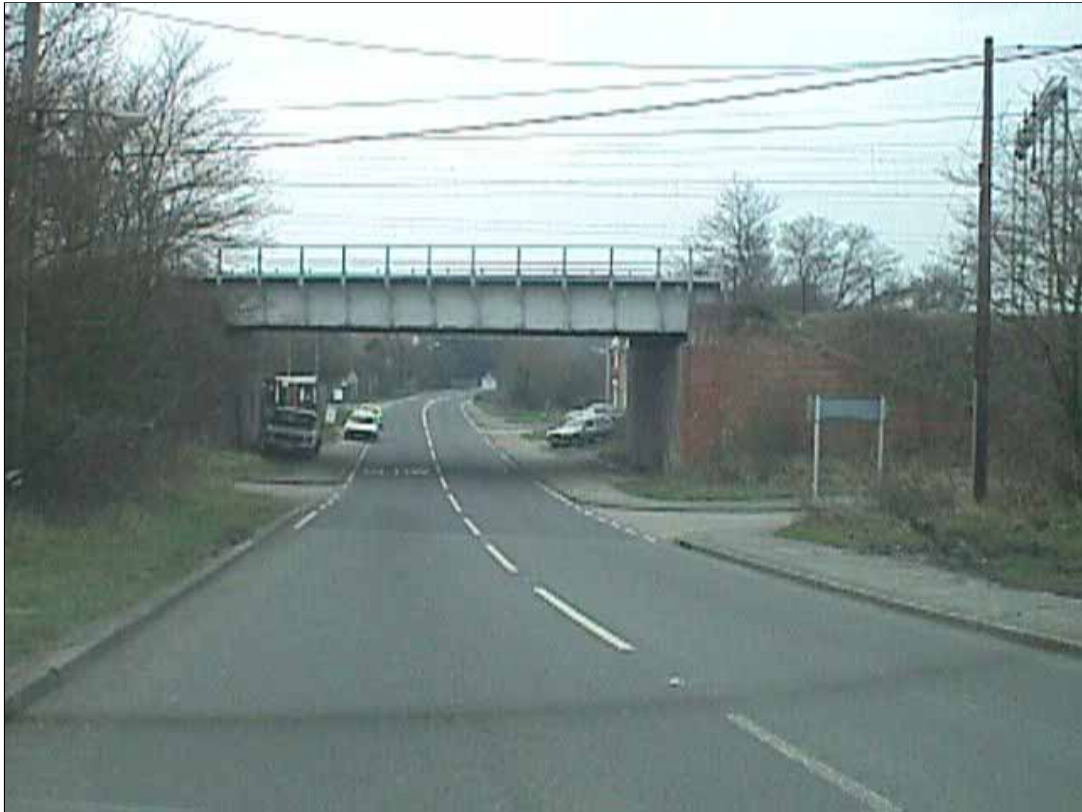
Of course there is one invention that can transform the safety of level crossings, its been around for centuries but the trouble is it very rarely passes the reasonable practicable test on grounds of cost – SLIDE 15 – the bridge.
