# Controlling dust during the refurbishment and extension of occupied premises

## Construction Occupational Health case study COH15

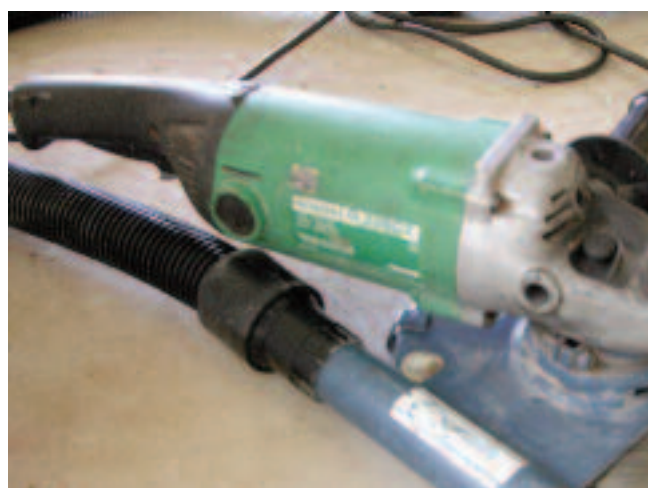
Figure 2

The particular intricacies of the site led to the area where the new extension joined the existing building being 'screened off'. This in itself helped restrict the spread of airborne dust into adjacent areas where food preparation took place.

At the point of breaking through into the old building water suppression could not be used due to the proximity of the main electrical circuit board. The hire company supplied a Dustcontrol 2800c dust extraction vacuum. The electric grinder used to cut through the brickwork was fitted with a source extraction guard.

The dust extraction vacuum was compact and ideal for the tight space that they were working in. Other workers in the area were unaffected by the dust.
