<b>Health and Safety Executive</b>		<b>Sector Information Minute</b>	
<b>Manufacturing</b>		<b>SIM 03/2003/03</b>	
<b>Cancellation Date</b>	07/03/2007	<b>Open Government Status</b>	Fully Open
<b>Version No &amp; Date</b>	2: 08/04/2003	<b>Author Unit/Section</b>	Engineering & Utilities - Birmingham

## **SAFETY AT TYPE B75 SALA ADIGE AUTOMATIC PIVOTING-HEAD METAL-CUTTING CIRCULAR SAWS**

This SIM alerts inspectors to the mechanical risks associated with Type B75 Sala Adige automatic, pivoting-head metal-cutting circular saws and gives advice on the standards of safeguarding.

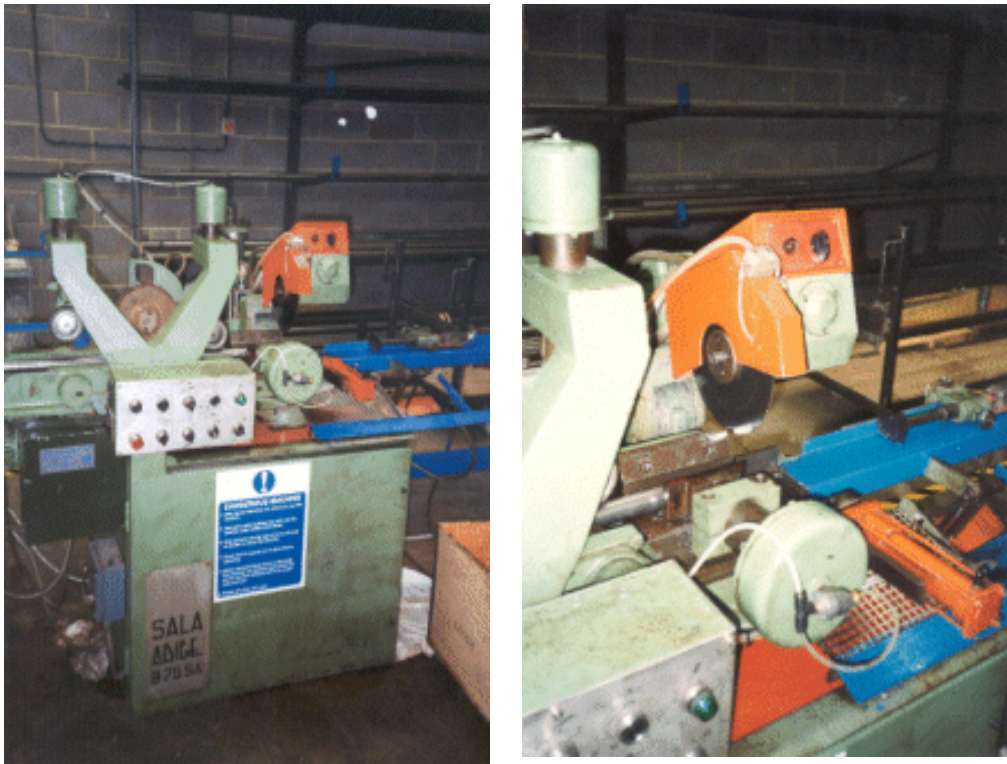
Photographs 1 & 2: Automatic fed Type A machine showing saw blade inadequately guarded with only 50% blade enclosure.

8 The original guarding on the B75 type machines comprised a fixed guard which enclosed only the top half of the saw blade (appendix [photographs 1 & 2](#)). However, with the need for frequent access to the area around the blade for setting, adjusting, feeding, retrieval of workpieces, swarf removal or cleaning, etc there was a foreseeable risk of inadvertent contact with the moving blade if the machine was not switched off and the blade stationary before such work was carried out. Accident experience indicated that, to maintain production and avoid inconvenience, operators did not always do this. Also that, because of the speed and quietness of rotation of the blade, it is not always immediately obvious that it is running. These issues were acknowledged by the manufacturers who fitted an additional substantial hinged, interlocked hood to provide greater blade enclosure at later machines.

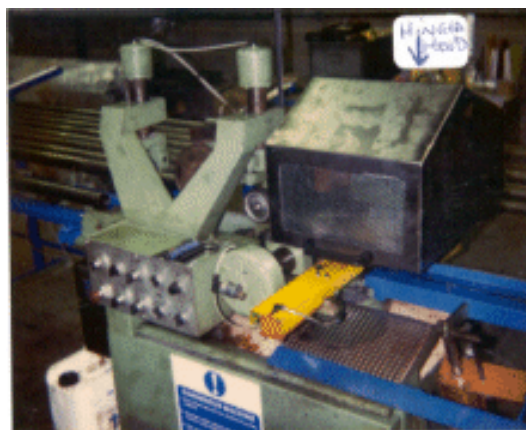
Photograph 3: Automatically fed Type A machine showing fitted additional hinged, interlocked hood guard to prevent inadvertent access to saw blade.

2) where this is not practicable, eg because of clamping and end-stop positioning etc, inadvertent access to the saw blade can be prevented by a suitably robust guard fitted around the saw-head assembly, and extending downwards to a position as close to the workpiece as practicable. A 'home-made' guard is shown in [photograph 3](#). (NOTE: the guard provided by the original manufacturer was ineffective). To allow ease of access to the saw-head, eg for adjustment of the blade, the guard may be hinged and interlocked. In such cases, the interlock should comprise a single switch suitable for safety applications installed in the positive mode in accordance with **British Standard BS EN 1088: 1996 Safety of machinery - interlocking devices associated with guards - principles for design and selection** and, where practicable, should keep the guard closed until movement of the blade has stopped;
