Inspecting and maintaining or replacing buried metallic pipework carrying LPG vapour

Advice for commercial and industrial users of LPG

This is a web-friendly version of leaflet INDG428, published 08/09. This replaces the previous leaflet published in 2006.

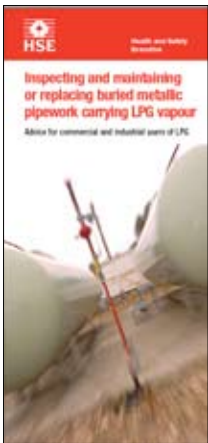
Metallic pipework protected as it enters the ground
