**Review of the 3-Year HSE Mattress
Manufacturing Initiative: Short Report**

ERG/09/35

Science Group: **Human Factors Science Group**

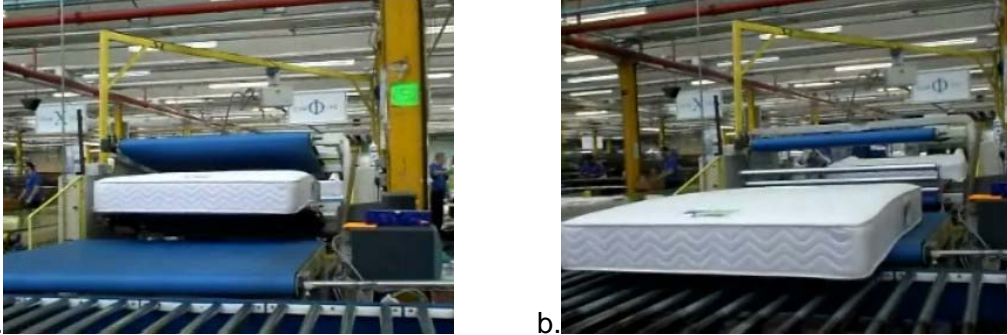
- **Work Organisation:** Of those that participated, manufacturers have considered work organisation factors that may reduce the risk from manual handling. One example of this was a modification to the flow of products through the factory, minimising the need for the products to be manually handled. As an additional benefit several manufacturers reported increased productivity as a result of improving work organisation. Photograph 1 shows a mattress leaving a mattress turner and being moved directly onto the conveyor to move through the production line.

Photograph 1. Mattress leaving the mattress turner and moving onto the conveyor system

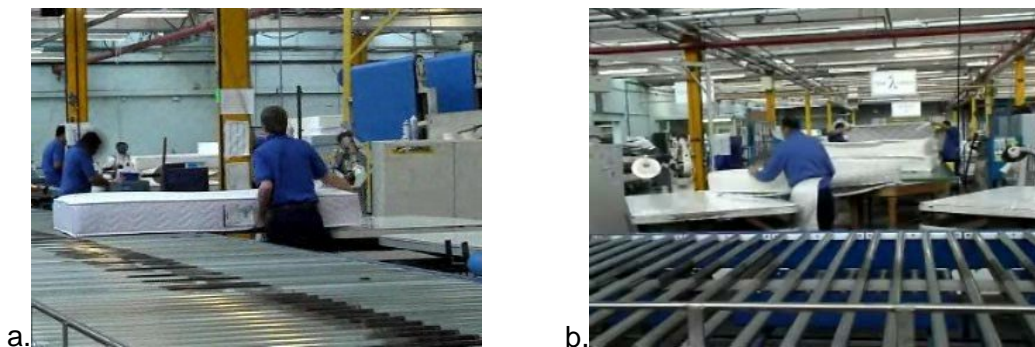
- **Use of Mechanised Equipment:** Companies reported that they were still willing to invest in mechanised equipment however, significant changes may currently be delayed until the economy improves. Examples of mechanised equipment are the installation of mattress turners, conveyors, assisted tape-edging machines, and automated packaging, and tufting machines. Other small changes that were observed during site visits that may help to reduce the risk of injury from manual handling. These included: having workbenches at the same height so that products can be slid from one workbench to the other rather than lifting and carrying (Photograph 2).

Photograph 2. Workbenches set at the same height as the conveyor

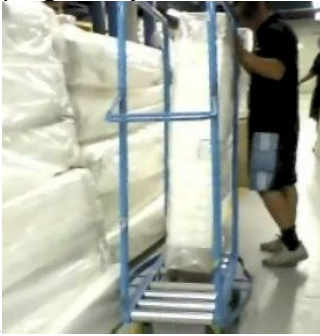
a.

- **Use of Handling Aids:** A variety of trolleys and dollies remain an important and simple means of transporting mattresses and divans within a factory, reducing lifting and carrying items (Photograph 3).

Tipping trolley for mattresses

Photograph 3. Examples of specialised trolleys to transport mattress (a&b) and fabric rolls (c)

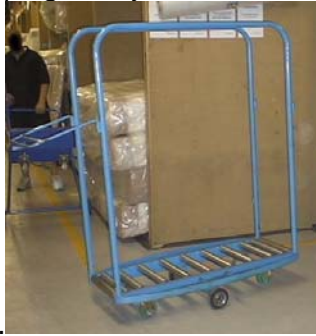
b.

Tipping trolley for mattresses

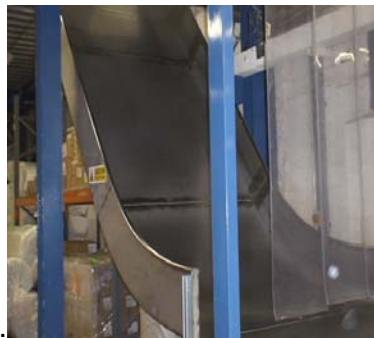
a.

- **Use of Other Transportation Methods:** Other manufacturers have come up with unique solutions to move mattresses and divans from one area to another. For example, the use of chute systems (Photograph 4. The chute where mattresses are delivered from the upstairs production area (a) and the end of the chute on the ground level (b)) conveyors, or lifts (Photograph 5), to transport mattresses from one level to another. The use of rollers was also observed to move divans stored in pallets (Photograph 6).

Photograph 4. The chute where mattresses are delivered from the upstairs production area (a) and the end of the chute on the ground level (b)

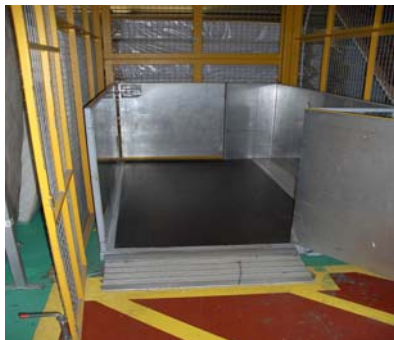
Photograph 5. Lift used to transport items from one level to another

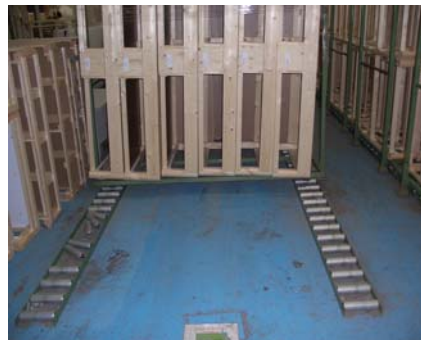
Photograph 6. Rollers used to help transport divan bases

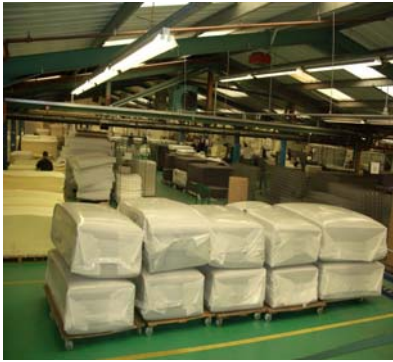
- **General Issues:**
 - **Storage of Products:** Other improvements were observed in how raw products and the finished mattresses and divans were stored, making them easier to be transported on pallets or in stillages thereby reducing unnecessary manual handling (Photograph 7, 8, and 9).

Photograph 7. Raw products stored on pallets can be easily transported by pallet truck

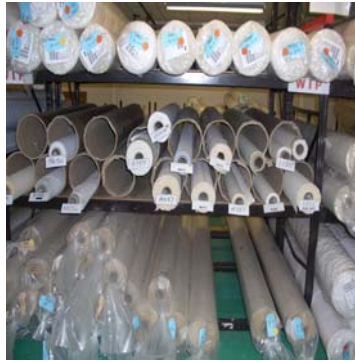
Photograph 8. Material stored in cylinders making them easier to access

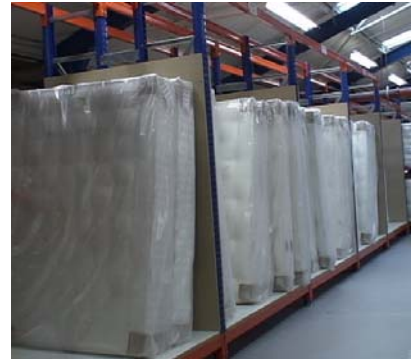
Photograph 9. Mattresses stored in allotted/organised storage areas

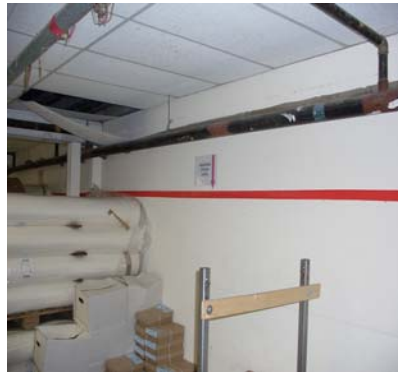
- **Reduction in Storage Heights:** The height at which products were stored or temporarily placed was also observed to have been lowered which will help to reduce the lifting and reaching above shoulder height.

Photograph 10. The painted red line indicates that products should not be stored above it

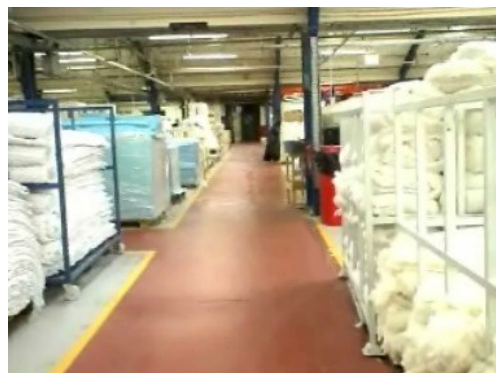
- **Clearly marked walkways:** These were observed and helped to keep the workplace ordered reducing some of the risks of individuals slipping or tripping (Photograph 11).

Photograph 11. An example of a clearly marked walkway with products stored in large trolleys so they can easily transported within the factory

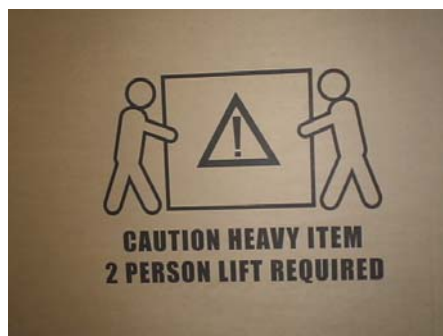
Photograph 12. Example of a warning label for a heavy product

- The Manual Handling Operations Regulations 1992 (as amended) does not place a duty on manufacturers or suppliers to mark weights on loads. However, they do have a duty under sections 3 and 6 of the Health and Safety at Work Act 1974 to protect people not in their employment who may be affected by handling loads they have supplied. Therefore, manufacturers still need to improve how they label the product weight on the finished item so it can quickly and reliably warn handlers when the load is heavy. Clearly marking products with the correct weight will help to enable all those in the distribution chain in making a dynamic risk assessment in terms of how they handle the product (e.g. do they need to use a trolley or seek assistance from a second individual?). An example of a handling warning is illustrated in Photograph 12.
